## **DETAIL: EPDM Low Slope Roof**

GENERAL DETAILS - DRAIN - ROOF COATING RESTORATION

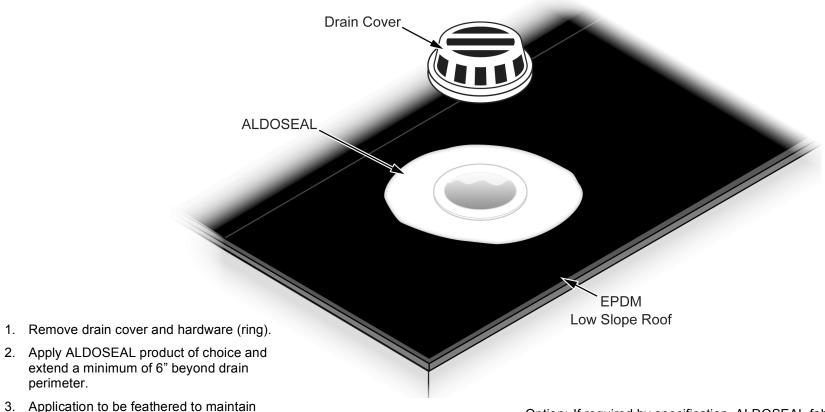
This detail drawing is intended to show the generally recommended procedure for dealing with the condition shown. Actual field conditions may vary. When such conditions vary slightly from the drawing, the intent and industry best practices are to be used. Any question, contact Aldo Products Company, Inc., Technical Department.

Option: If required by specification, ALDOSEAL fabric is used in a three course application method with ALDOSEAL product of choice.

positive water drainage.

4. Re-install ring, hardware and drain cover.
