DETAIL: Modified Bitumen (Mod Bit) Low Slope Roof

GENERAL DETAILS – SEAMS – ROOF COATING RESTORATION

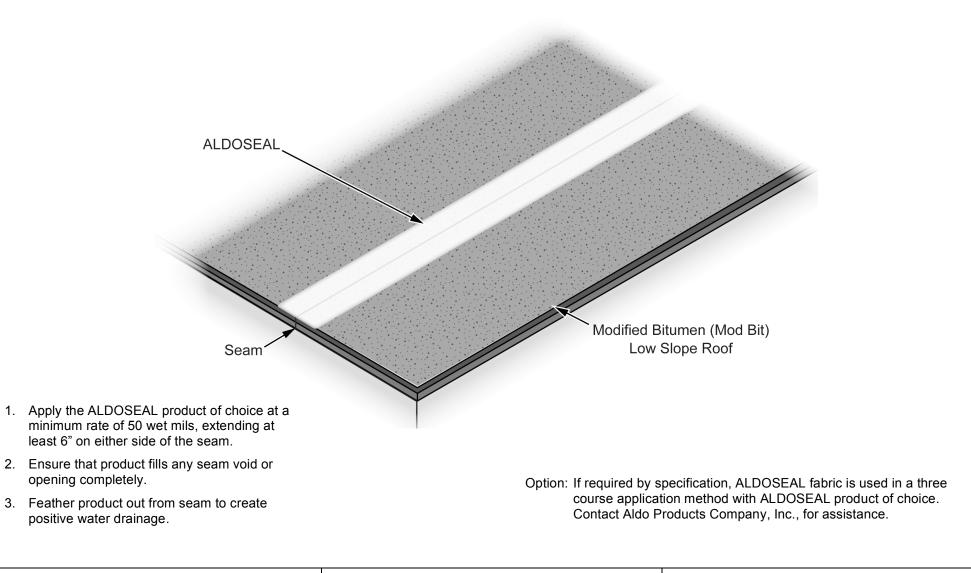
This detail drawing is intended to show the generally recommended procedure for dealing with the condition shown. Actual field conditions may vary. When such conditions vary slightly from the drawing, the intent and industry best practices are to be used. Any question, contact Aldo Products Company, Inc., Technical Department.
