## **DETAIL: TPO Low Slope Roof**

GENERAL DETAILS - SEAMS - ROOF COATING RESTORATION

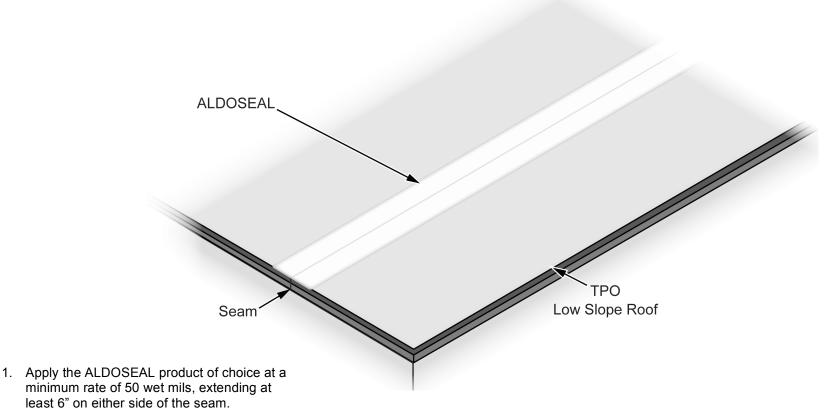
2. Ensure that product fills any seam void or opening completely.

3. Feather product out from seam to create positive water drainage.

Option: If required by specification, ALDOSEAL fabric is used in a three course application method with ALDOSEAL product of choice.
