DETAIL: EPDM Low Slope Roof

GENERAL DETAILS – PIPE PENETRATION – ROOF COATING RESTORATION

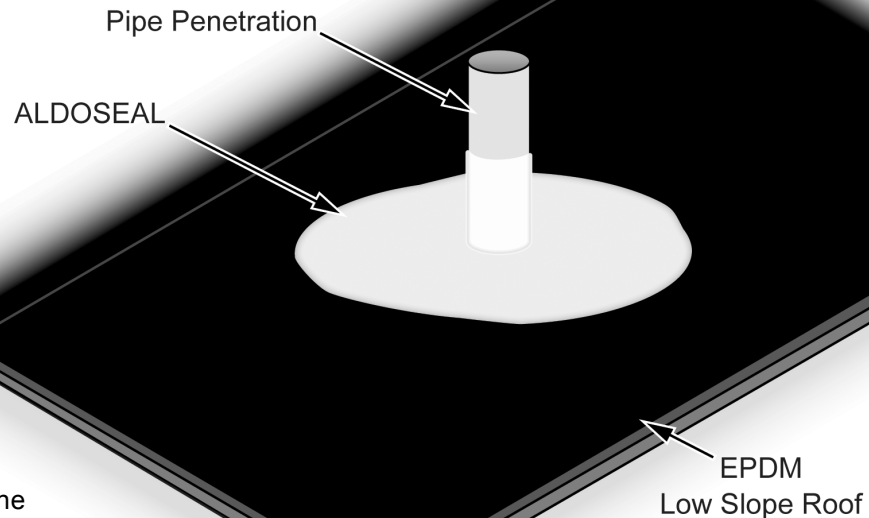
This detail drawing is intended to show the generally recommended procedure for dealing with the condition shown. Actual field conditions may vary. When such conditions vary slightly from the drawing, the intent and industry best practices are to be used. Any question, contact Aldo Products Company, Inc., Technical Department.

1. Apply a minimum of 50 wet mils of the ALDOSEAL product of choice around the base of pipe, extending 8-12" from the pipe.
2. Apply material up pipe a minimum of 6" up the pipe, feathering application towards the top of the pipe.
3. Make sure all voids are filled.
