DETAIL: TPO Low Slope Roof

GENERAL DETAILS - ROOFTOP CORNERS - ROOF COATING RESTORATION

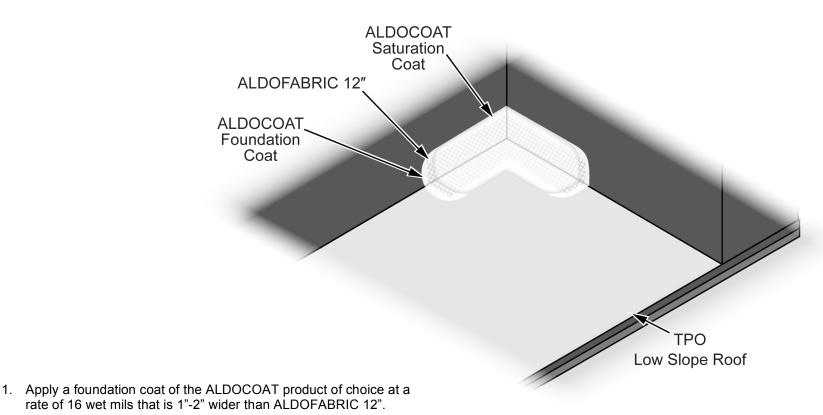
- 2. Immediately embed ALDOFABRIC 12" into wet coating, ensuring fabric is smooth and flush to surface without any wrinkles.
- 3. Apply a saturation coat of 16 wet mils of the ALDOCOAT product of choice over the ALDOFABRIC 12", ensuring the fabric is completely encapsulated with coating. Coating should extend 1"-2" past every edge of the fabric.
