DETAIL: Metal Roof - Ribbed

GENERAL DETAILS – RIDGE CAP – ROOF COATING RESTORATION

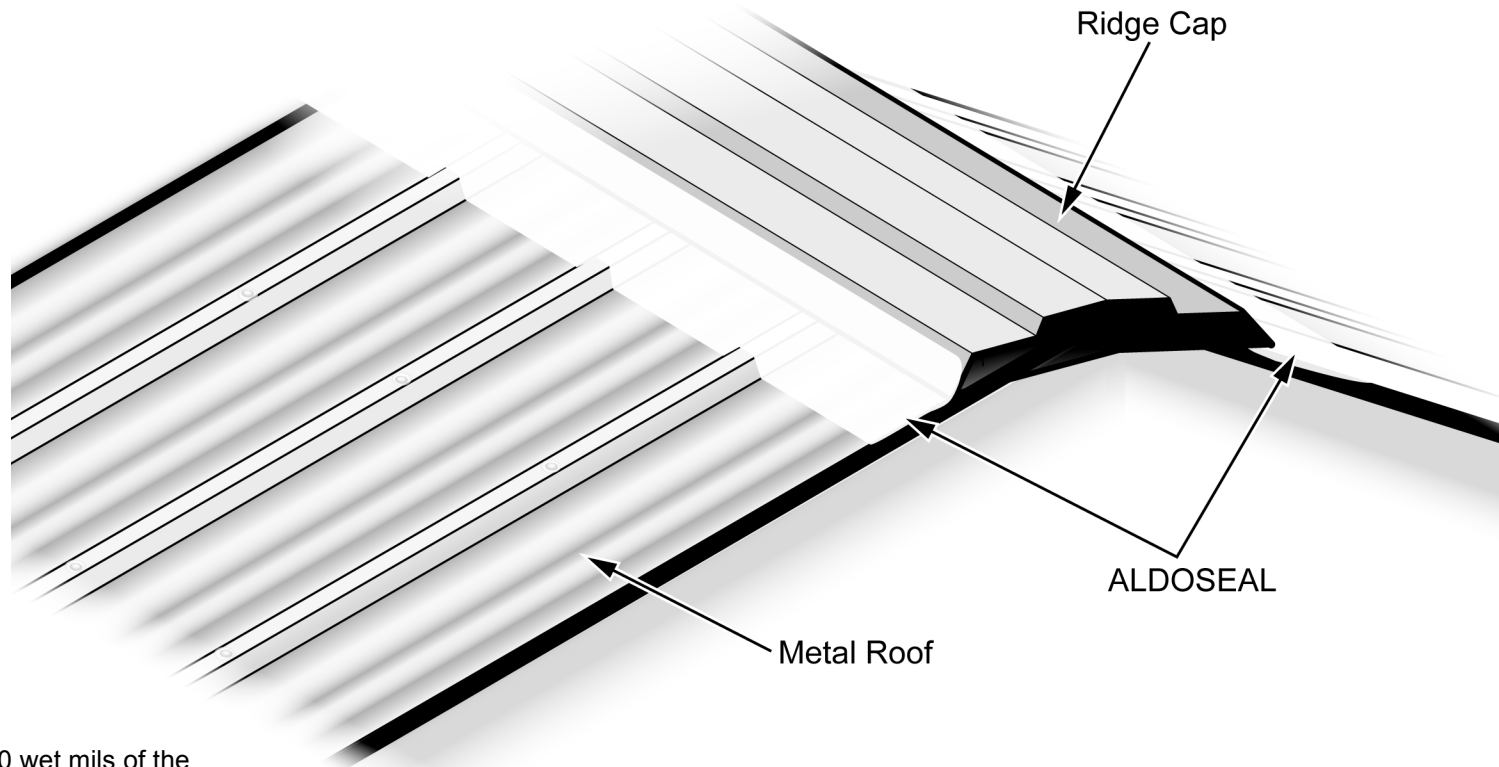
1. Brush apply 50 wet mils of the ALDOSEAL product of choice 6" from the ridge cap over onto the existing metal roof panel.
2. All voids or openings are to be filled completely.
3. The ALDOSEAL product is to be applied and feathered to create positive drainage of any water flow.

This detail drawing is intended to show the generally recommended procedure for dealing with the condition shown. Actual field conditions may vary. When such conditions vary slightly from the drawing, the intent and industry best practices are to be used. Any question, contact Aldo Products Company, Inc., Technical Department.
